POLREP No. 3

Date: November 06, 2000  
Subject: Hackberry Pits  
From: OSC Robert M. Ryan, P.E., U. S. EPA Region 6  
To: Director, ERD  
Charles A. Gazda, Chief, RPB, Region 6

### **A. Incident Category: Abandoned Oil Production Facility**

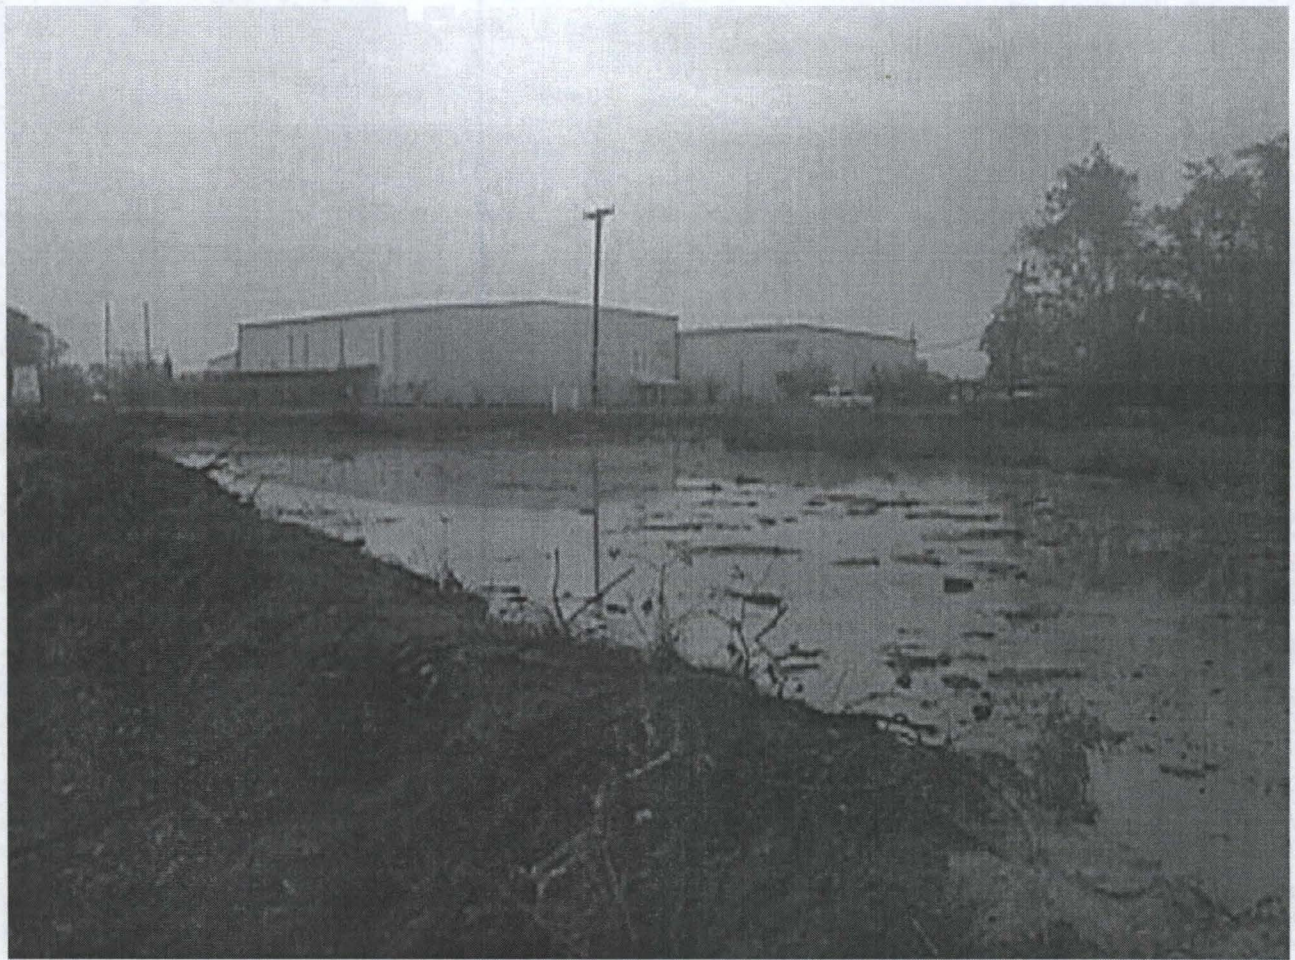
Standing water on Pit 1 after an evening shower.  
Vacuum truck pumping water from frac tank.

During the week of November 04, 2000, IT continued to pump water from Pit 1 into frac tank A. L&L Environmental Services supplied a 130-bbl vacuum truck to transport the water pumped from Pit 1 to U.S. Liquids in Mermentau, Louisiana for disposal. Since a vacuum truck was available to haul the wastewater offsite, frac tank B was demobilized from the site. The 130-bbl vacuum truck hauled off approximately 26,502 gallons of water from Pit 1 in six trips. The contractor mixed the pit contents to release any pockets of water located under the sludge layer. The mixing procedure involved using the bucket of the excavator to push the contents of the pit back and forth to allow water to rise to the surface. A decision was made to reduce the crew size from four to two personnel during pumping activities.
